STAMP Tag Deploying Form

I.	Tagged by: _ Horatio Gordon & Donna	
2.	Tag Number(s) (####):_Test Tag 0000d	
3.	Date: _June 8, 2023 Time : _	10:45 am pm
	Tide level: High Medium Lo	w N/A

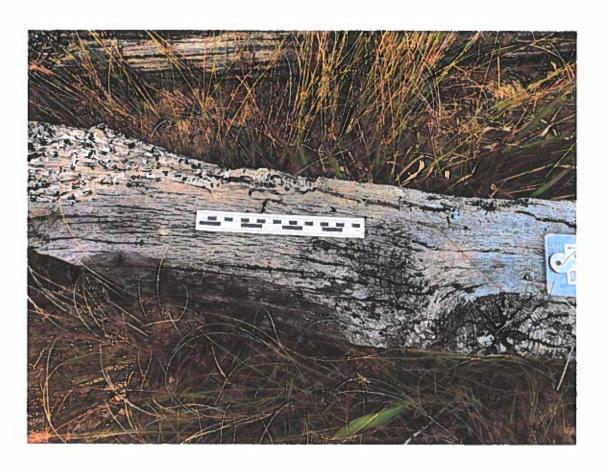
Test Tag 0000d 1

6.	Main Material of Construction: What is the wreckage material?	Skip the following questions if not wooden wreckage
	X Wood \square Steel \square Iron \square Fiberglass	If the wreckage is wood, does it
		appear to be:
	Check the following boxes if these details are present on the wreckage:	☐ Hand hewn x Machine Cut ☐ Both ☐ Other
	X Treenails	Look at the images on the
	Round Spikes x Other	instruction sheet and give your best guess on what part of the
	Check the following boxes if the materials are present on the wreckage:	shipwreck you believe you foundFloor timber? Futtock?
	X Wood x Iron Copper Steel	
	X Iron spike concreted & staining

7.	Deterioration: What does the level of deterioration seem to be?		
_	No deterioration x Partially deteriorated Heavily deteriorated		
8.	Exposure: Check the best choice for how exposed the wreckage is:		
	x Completely exposed Partially exposed Nearly covered

13. Comments: _Teredo navalis(shipworm) damage).			
	Please send this completed form to susan.langley@maryland.gov with photos. Scans of the form or legible		
	photos are acceptable or mail to: Dr. S. Langley, Maryland Historical Trust, 100 Community Place,		
	Crownsville, MD 21032.
